he concrete slab measured up to 39 inches thick in some areas, but hydrostatic pressure in the ground below the slab had caused it to crack and break. The upward movement of the ground had pushed broken concrete sections up from the slab and created hazards for the keels of docking ships and the positioning of support blocks. Vessels are floated into graving docks and positioned on blocks before the dock is drained of all water so crews can perform maintenance or repairs on the vessel in a dry environment. The displacement of the earth beneath the basin floor had also caused damage to parts of the dock's drainage and pump systems, rendering them unusable until the slab could be removed and repairs made.

The broken and cracked areas of the slab were to be demolished, removed and replaced. As part of this project, CSDA member Concrete Cutting & Breaking Co. was contracted to use sawing and drilling techniques and create sections of concrete that would be manageable for the general contractor—CCC Group, Inc. of Corpus Christi—to remove by crane. The speed, low vibration and precision associated with diamond

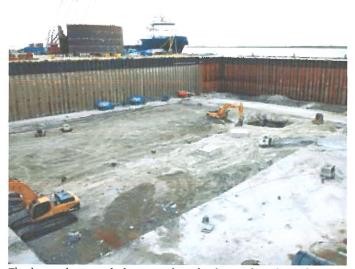
Tools and equipment were lowered to the dock basin by crane.

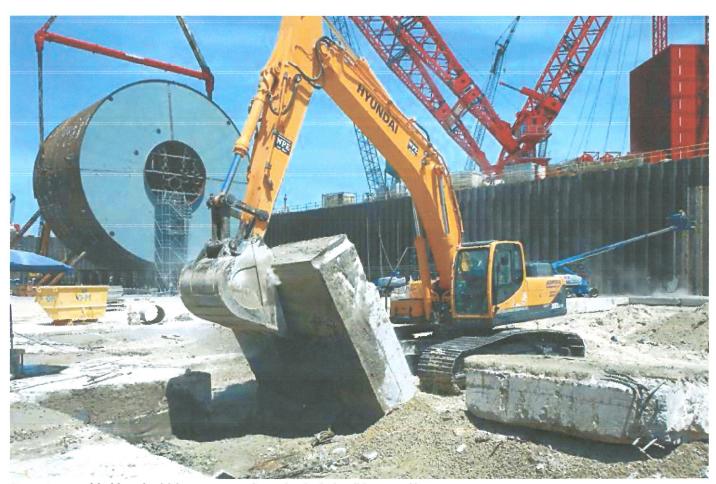
Cut sections were lifted from the slab by excavators and moved to the dock wall for removal by crane.

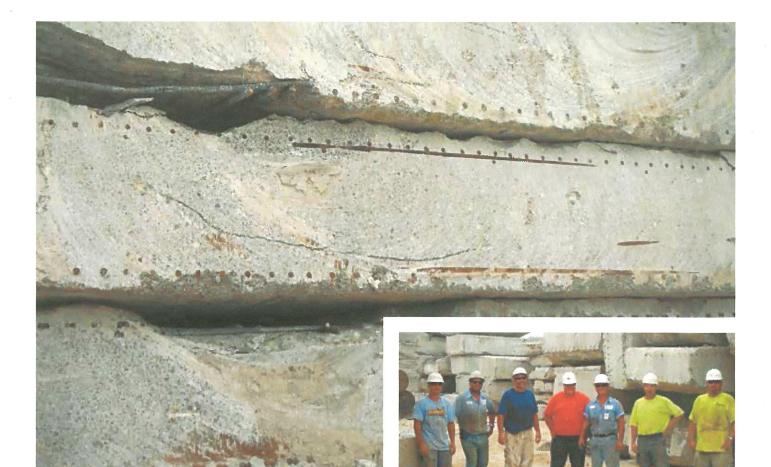
Operators cut approximately 44,700 cubic feet of concrete.
